# Service Bulletin

ISSUE NO. : 09-009

SUBJECT	<b>MODIFICATION OF CLUTCH OUTER COVER</b>	
MODEL	GT-650, GV-650	
EFFECTIVE F/M NO	REFER TO APPLICATION

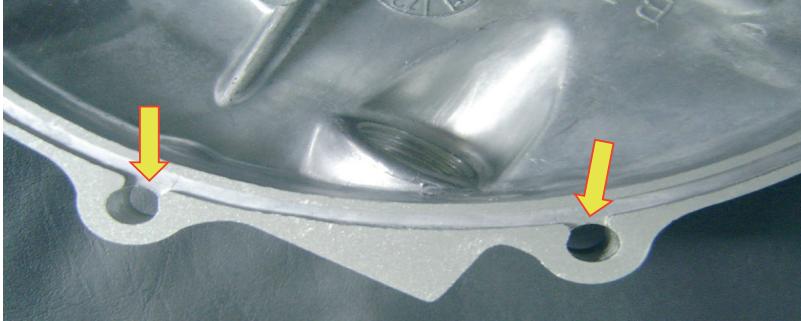
Joint groove of O-ring is connected with screw hole. When a screw is tightened the screw pushes the O-ring and it causes an oil leak through the hole.
<AFTER>
